# HEAVYWEIGHT HIGH IMPACT (H.I.) SHOCK TEST REPORT

**July, 2003**

Dynamic Testing • A Division of DTI Holdings, LLC • P.O. Box 494, 3915 Sunnymeade Rd., Rustburg, VA 24588 • 434-846-0244 • dti@dynatest.net

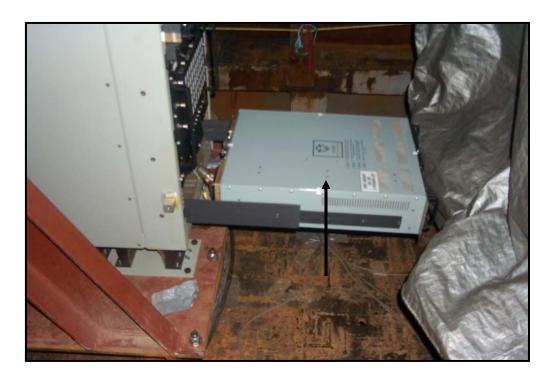
**NOTE 1:** The UPSs on only two of the four cabinets were operational during the first two shots.

Photograph No. 8. New UPS

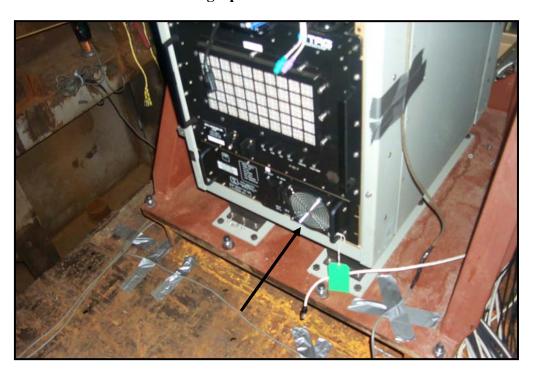
Photograph No. 9. Location of New UPS in Racks

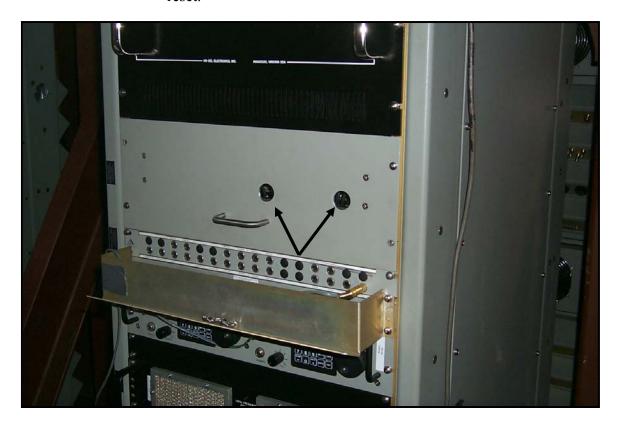
**Observation 1:** The KVM and keyboard were not operational in the System Control Rack.

**Observation 1:** The KVM and keyboard was not operational in the System Control Rack.

Photograph No. 10. Modification to KVM Cover

**NOTE 2:** To enable the operator of the rack to reset the KVM, the cover was removed and modified, as seen in Photograph No. 10. Two 1-inch holes were drilled into the cover to allow for operator reset.

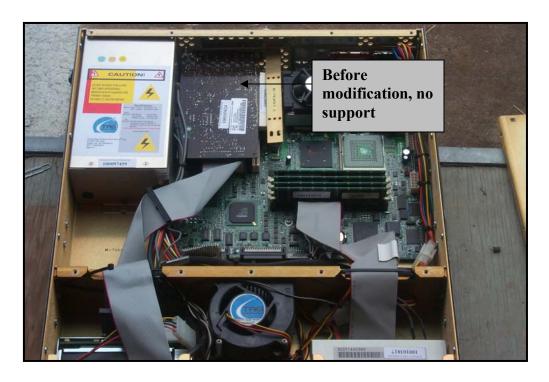
Photograph No. 11. Before Modification

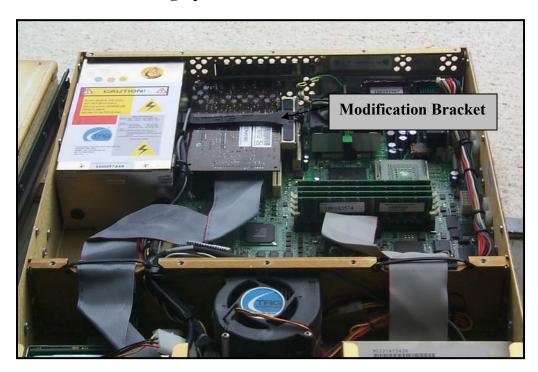
Photograph No. 12. After Modification
