VIBRATION QUALIFICATION TESTING

OPTIMA EPS
1775 MCLEOD DRIVE
LAWRENCEVILLE, GA 30043

MATERIALS TEST REPORT

Vibration testing on an equipment shelf system

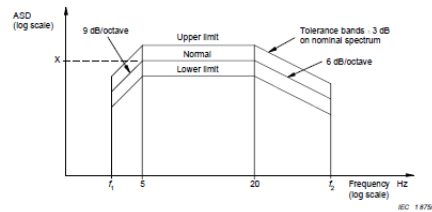
when mass	<500 kg:	$f_1 = 5 \text{ Hz}$	$f_2 = 150 \text{ Hz}$
when mass	>500 kg < 1 250 kg:	$f_1 = \frac{1\,250}{\text{mass}} \times 2 \text{ Hz}$	$f_2 = \frac{1\,250}{\text{mass}} \times 80 \text{ Hz}$
when mass	>1 250 kg:	$f_1 = 2 \text{ Hz}$	$f_2 = 80 \text{ Hz}$

Vertical	Transverse	Longitudinal
Functional test ASD level (m/s ²) ² /Hz	0,0298	0,0060	0,0144
RMS value m/s ² 5 Hz to 150 Hz	1,00	0,45	0,70
Long life test ASD level (m/s ²) ² /Hz	1,857	0,366	0,901
RMS value m/s ² 5 Hz to 150 Hz	7,9	3,5	5,5

Figure 2 - Category 1 - Class B - Body-mounted - ASD spectrum

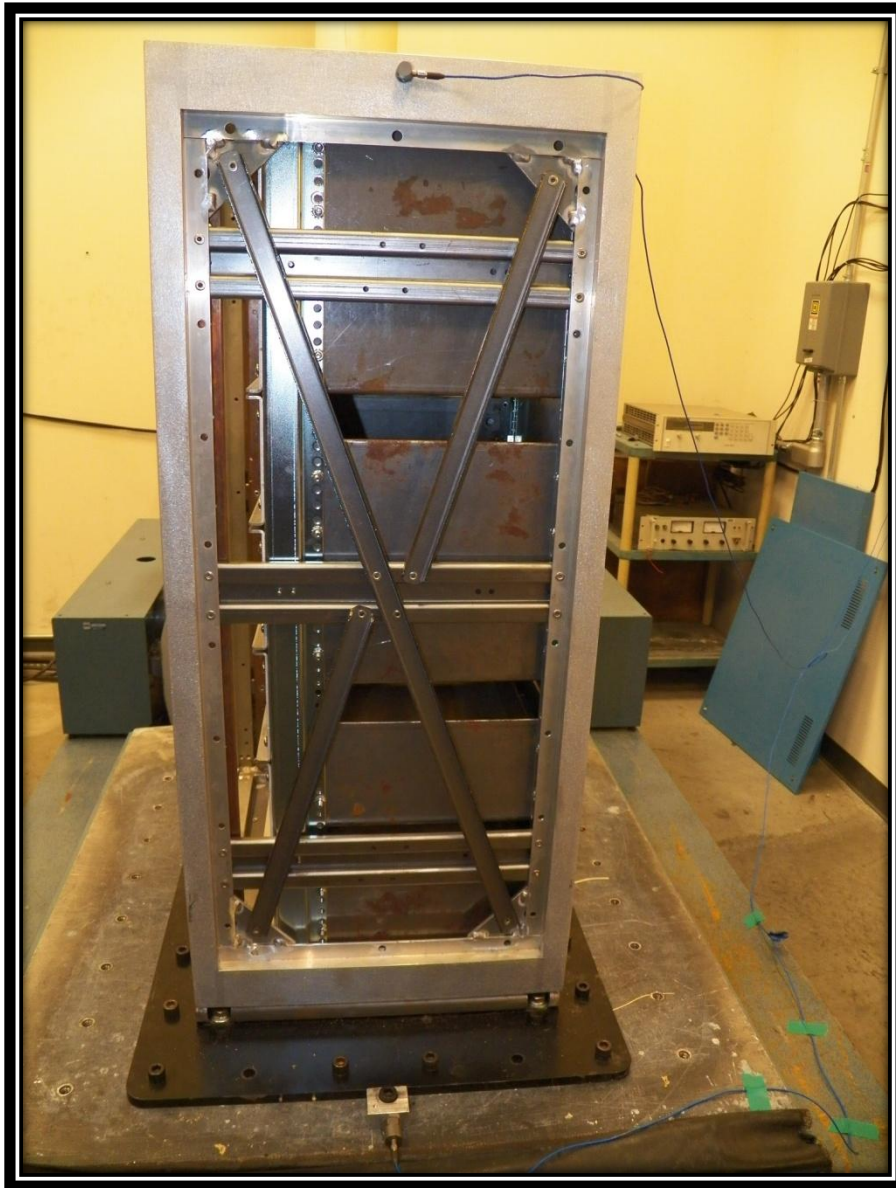
Figure 1: View of the test setup – Longitudinal Direction

The sample was bolted to an electrodynamic shaker table as illustrated in Figures 1-3.

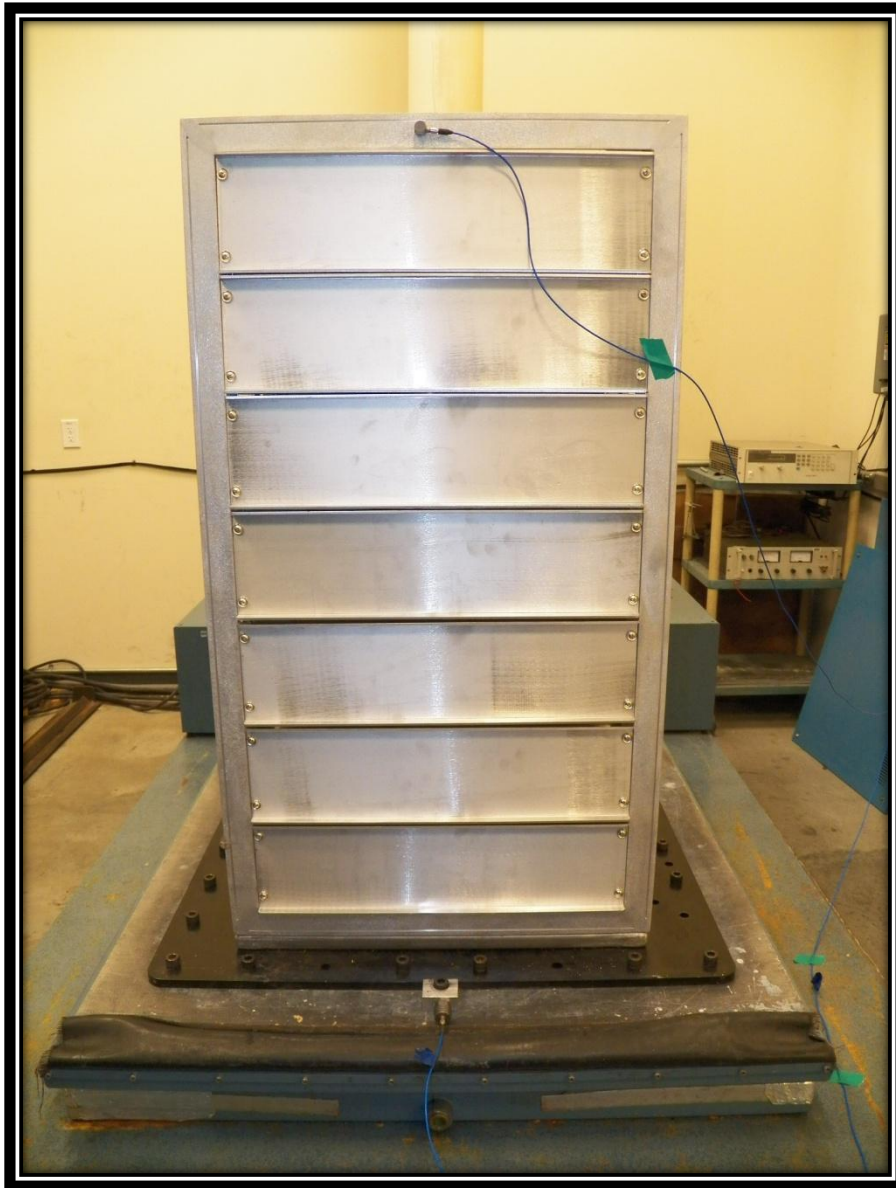
Figure 2: View of the test setup – Transverse Direction

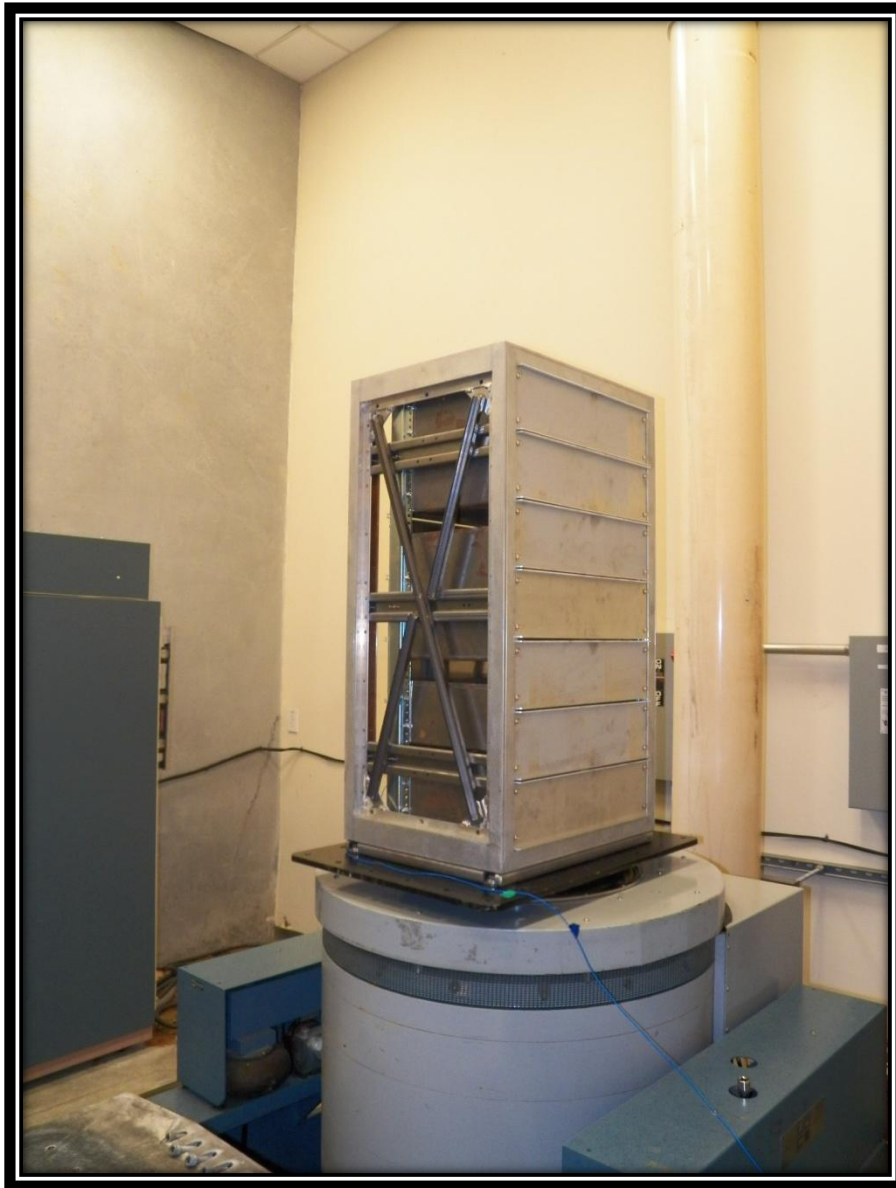
Figure 3: View of the test setup – Vertical Direction

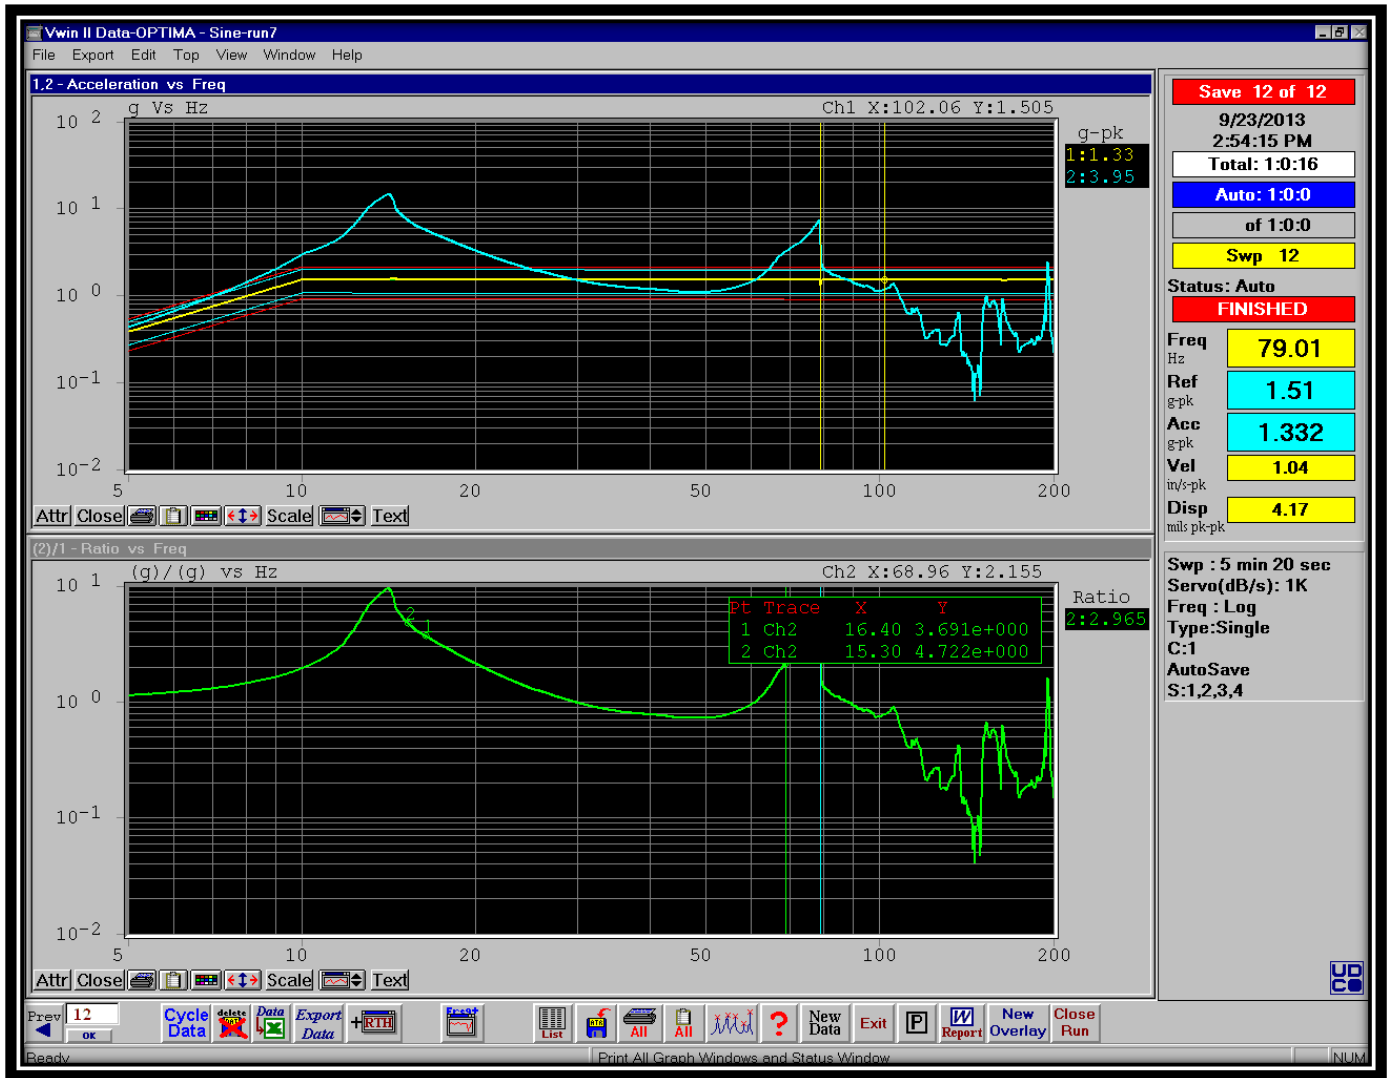
Figure 4: AREMA profile – Sinusoidal vibration – Longitudinal Direction

The sinusoidal vibration profiles shown in Figures 4-6 were applied to the unit along each mutually perpendicular axes (Longitudinal, Transverse, Vertical) for a duration of 1 hour/axis.

5Hz-10Hz: 0.3" peak to peak displacement

10Hz-200Hz: 1.5G peak acceleration

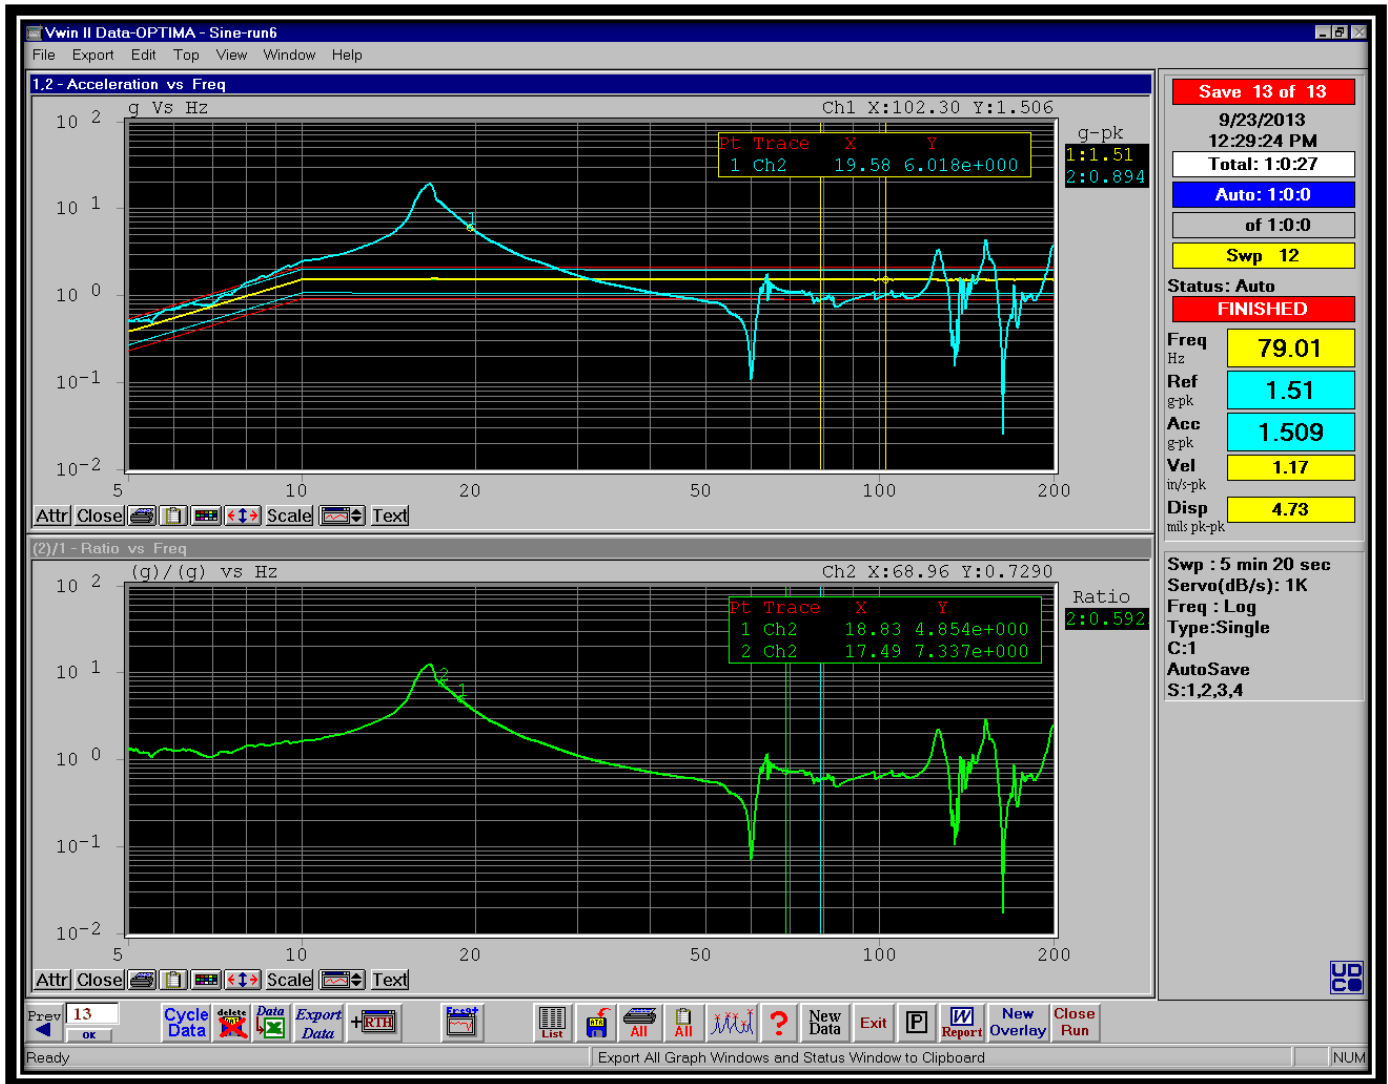
Figure 5: AREMA profile – Sinusoidal vibration – Transverse Direction

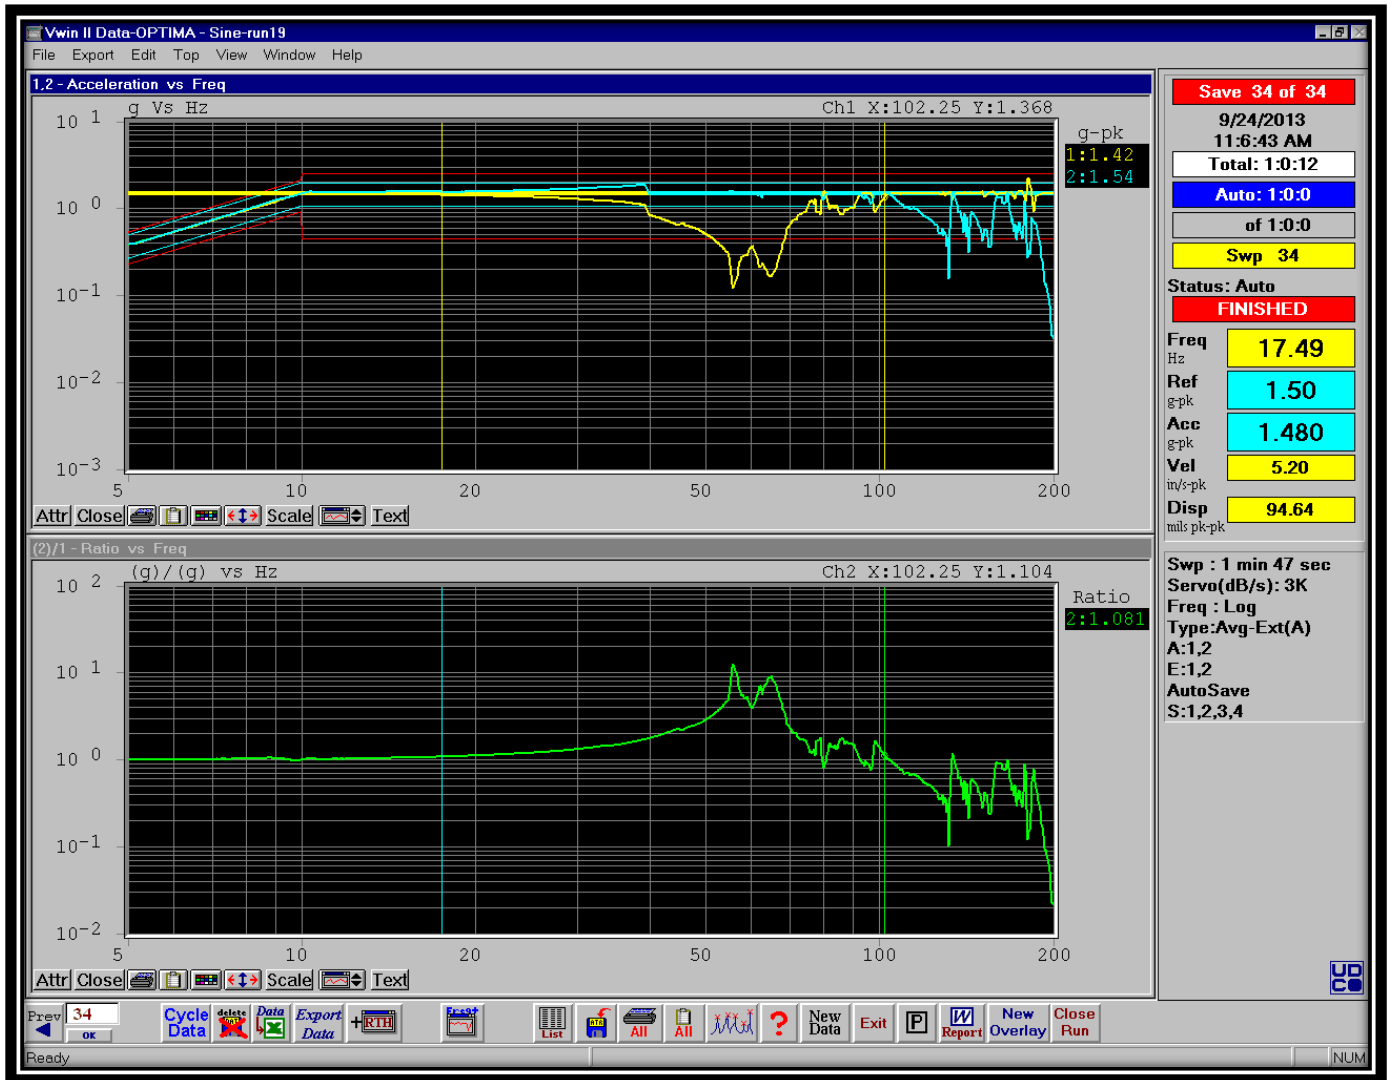
Figure 6: AREMA profile – Sinusoidal vibration – Vertical Direction

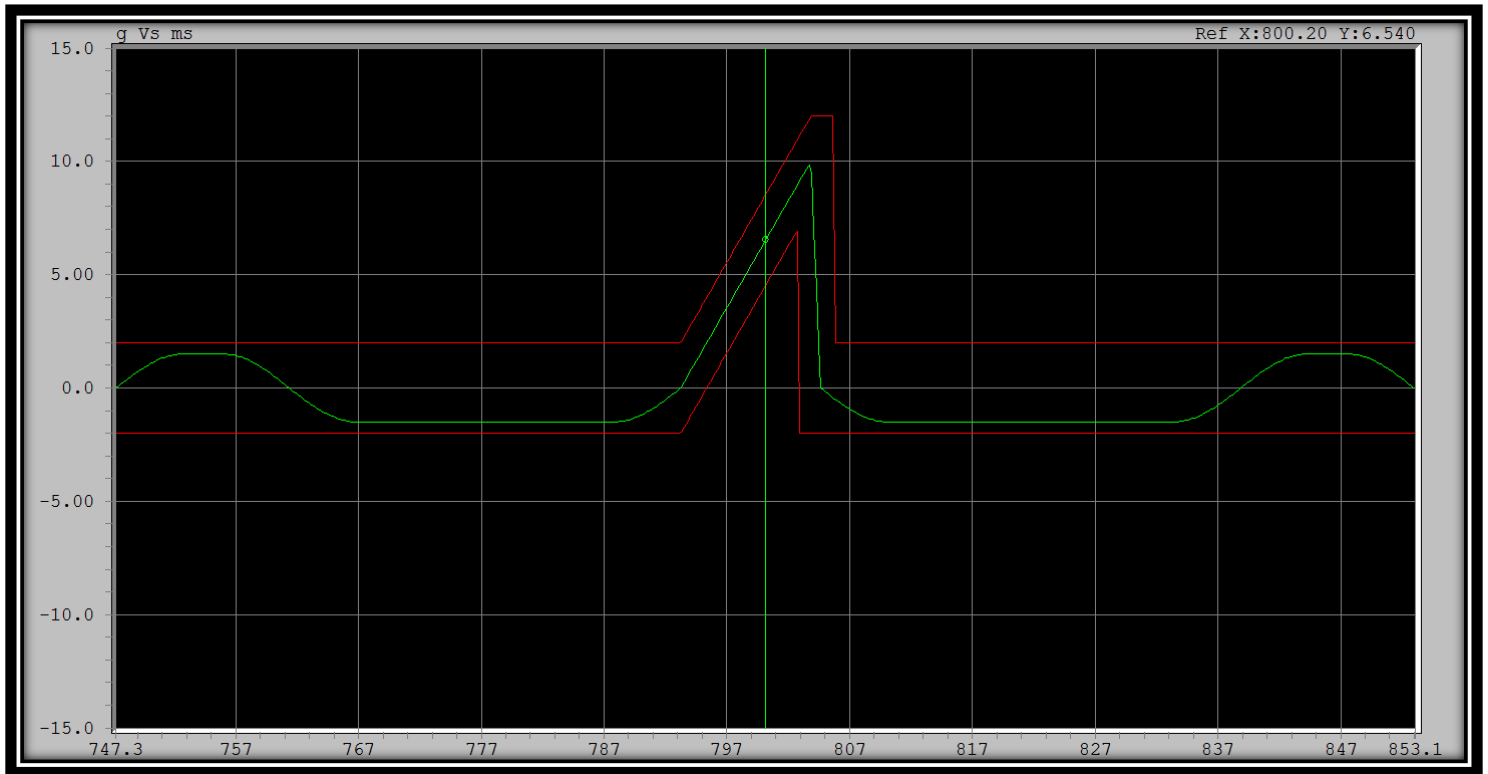
Figure 7: AREMA – 10G, 11ms, Terminal Sawtooth

A 10G peak, 11ms pulse width, terminal sawtooth waveform was applied along each direction.

Figure 7 shows the corresponding acceleration time history.

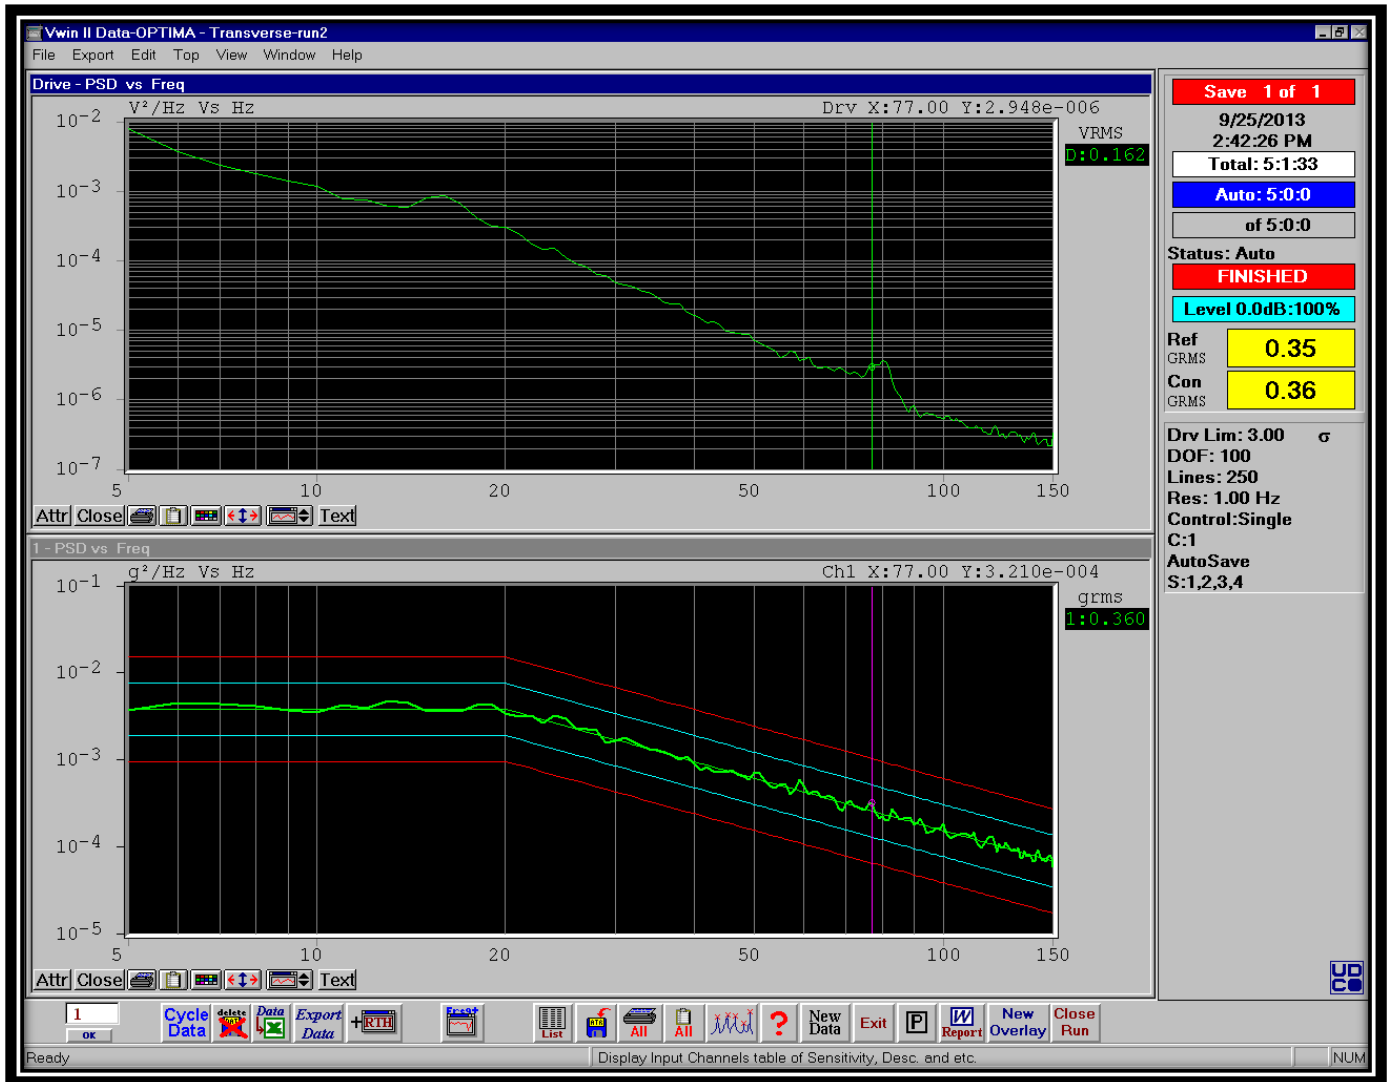
Figure 9: IEC profile – Random vibration – Transverse Direction

The random vibration profiles shown in Figures 8-10 were applied to the unit along each mutually perpendicular axes (Longitudinal, Transverse, Vertical) for a duration of 5 hours/axis (Long Life test).

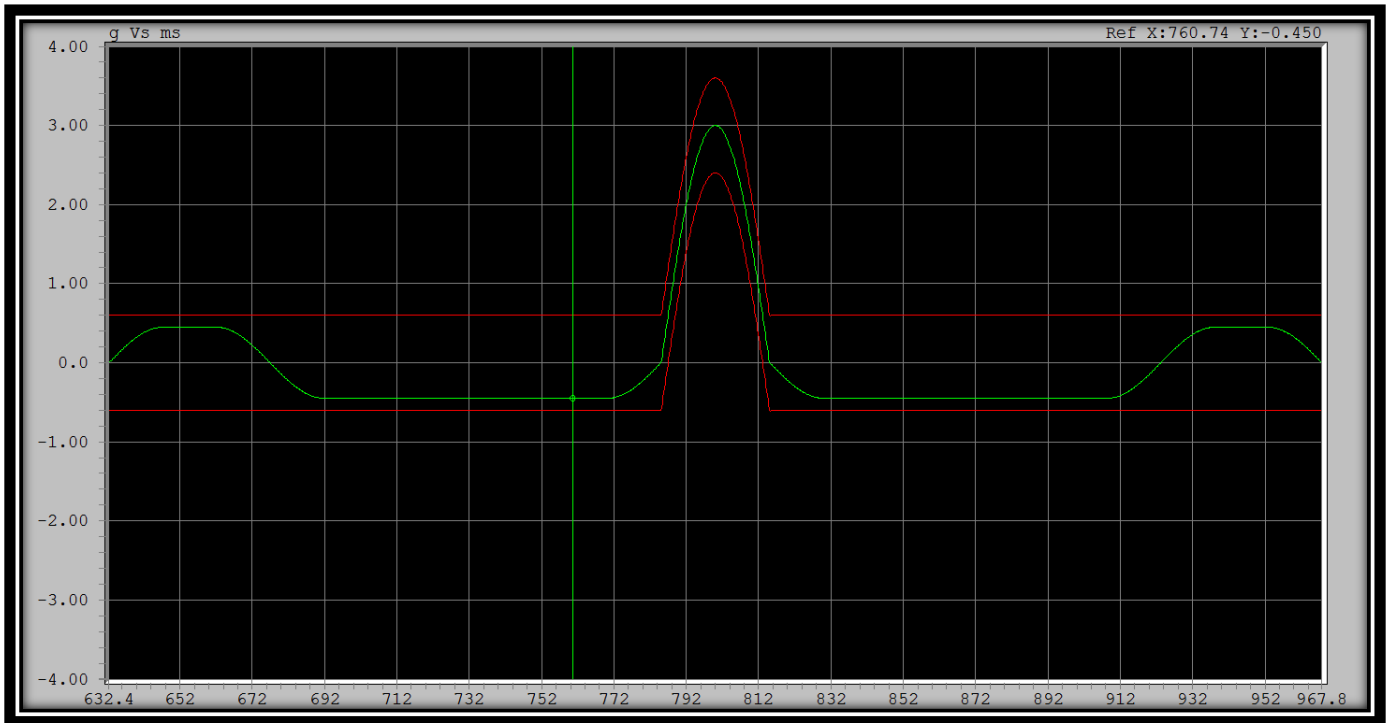
Figure 11: IEC – 3G, 30ms, 1/2-Sine

With the assembly oriented along the transverse and vertical axes, Three (3) 3G peak, 30ms pulse width, ½-sine waveform shocks were applied along each direction. Figure 11 shows the corresponding acceleration time history.

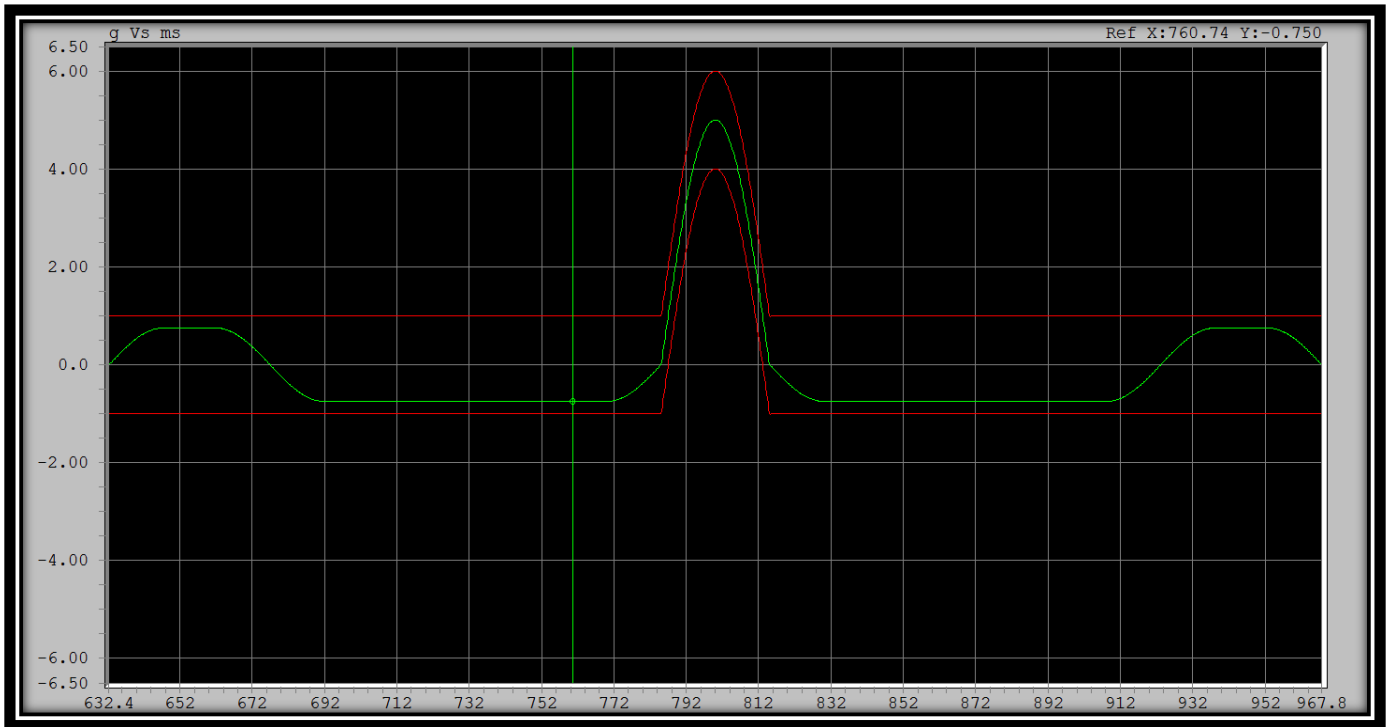
Figure 12: IEC – 5G, 30ms, 1/2-Sine

The longitudinal axes was subjected to Three (3) 5G peak, 30ms pulse width, ½-sine waveform shocks (see Figure 12)
