# HEAVYWEIGHT HIGH IMPACT (H.I.) SHOCK TEST REPORT

**July, 2003**

Dynamic Testing • A Division of DTI Holdings, LLC • P.O. Box 494, 3915 Sunnymeade Rd., Rustburg, VA 24588 • 434-846-0244 • dti@dynatest.net

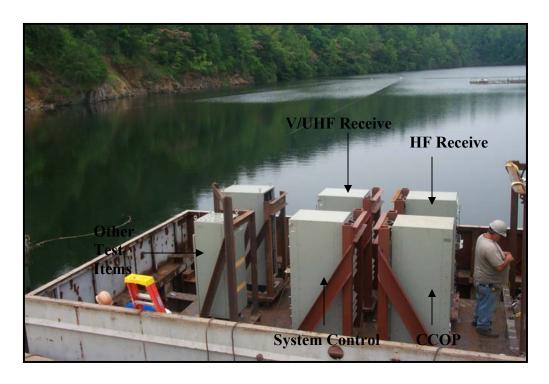
Photograph No. 1. Overhead View of Initial Installation, Shots 1-3

Photograph No. 1 shows the installation for Shots 1 through 3.

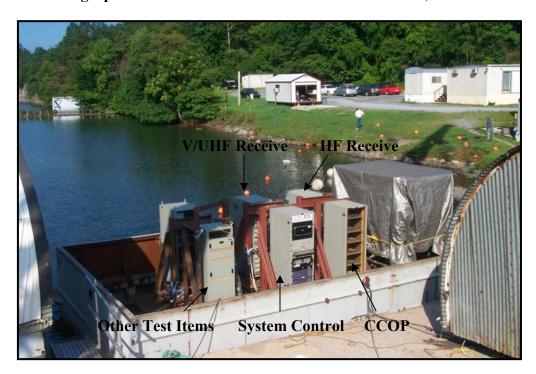
Photograph No. 2. Overhead View of Initial Installation, Shot 4

Photograph No. 2 shows the installation for Shot 4.

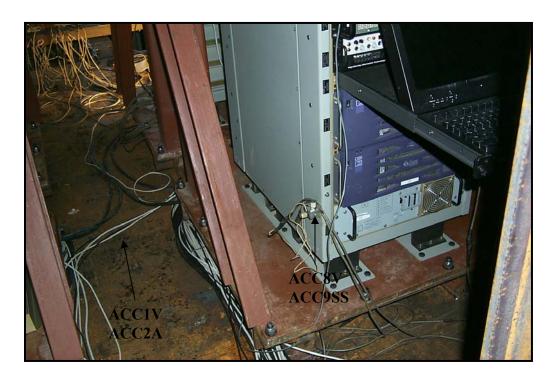
**Photograph No. 3. Instrumentation Locations**

The fundamental vertical response of the DSF was determined from the peak response on a fast fourier transform (FFT) generated from acceleration time-history data measured at Sensor A1V (see Photograph No.3). Deck frequency and support locations are summarized in Table 2.

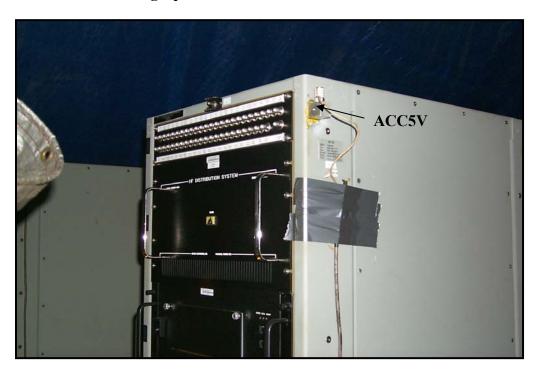
Photograph No. 4. Instrumentation Location

**NOTE:** The EUT was rotated 90° after completion of the post-shot inspection. Photograph No. 4 shows the rotated test setup.
